CERTS MICROGRID LABORATORY TEST BED

Test Plan Section 7.0
Validate Protection Settings and
Initial Fault Testing

Prepared By:
Lawrence Berkeley National Laboratory

SECTION 7.0

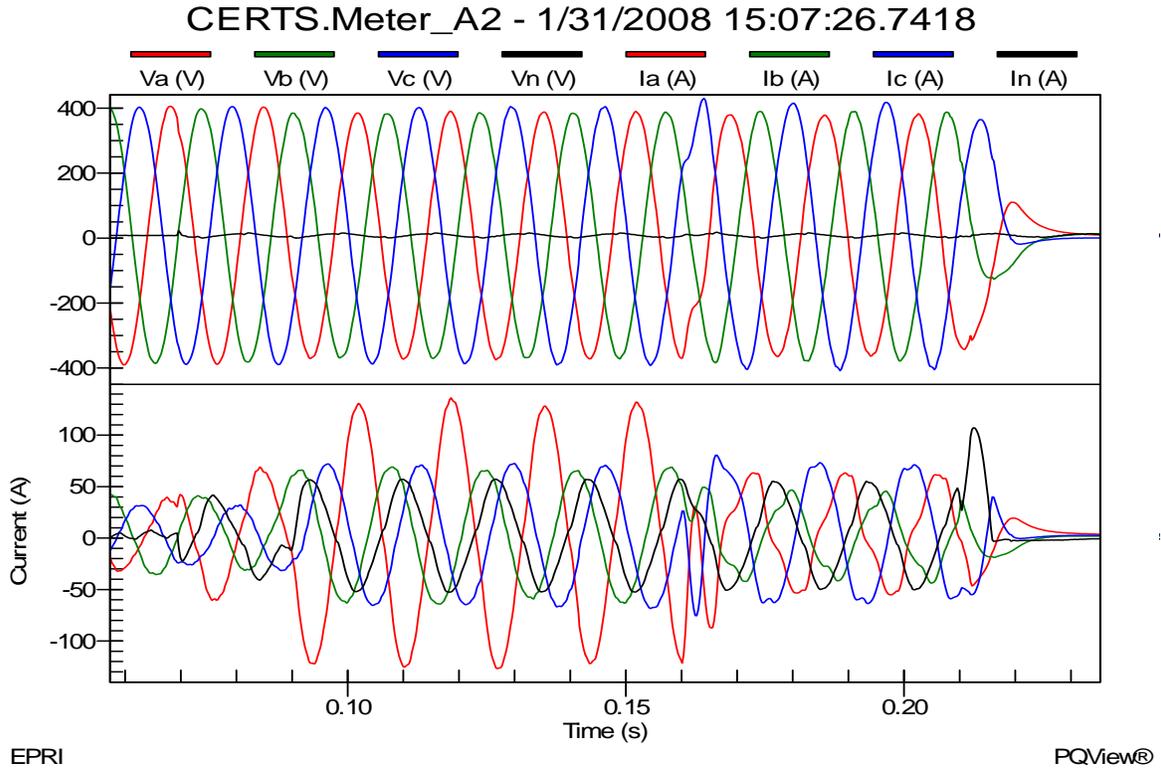
Figure 15f - Meter A2 voltage and current for a single phase-to-ground fault applied in Zone 3.

Figure 15e - Meter 4 (CB41) voltage and current for a single phase-to-ground fault applied in Zone 3.
 A complex situation took place in Figures 15e, 15f and 15g. The fault was applied at 0.07 seconds which caused the static switch to open at 0.09 seconds. This was followed by a short period where both Gen-sets A1 and A2 were supporting the microgrid load, as well as the fault overload, shown in Figures 15f and 15g between 0.09 and 0.16 seconds. At 0.16 seconds Relay 4 commanded Gen-set A2 to shutdown and CB41 to open. Gen-set A2 first stopped delivering power to the microgrid, as seen by the sudden increase of current at Meter 4, Figure 15e, and Meter A1, Figure 15g. Even though Gen-set A2 stopped switching the inverter output, its interface transformer remained connected to the microgrid. This is evident by the continued current flow though Meter A2 after 0.16 seconds, Figure 15f, due to the Wye/Delta transformation, and also evident in the real power transferred from B and C phases to A phase at Meter A2 in Figure 15h. At 0.215 seconds CB41 opened reducing the current through CB41 to zero and denergizing Zone 4 of the microgrid.

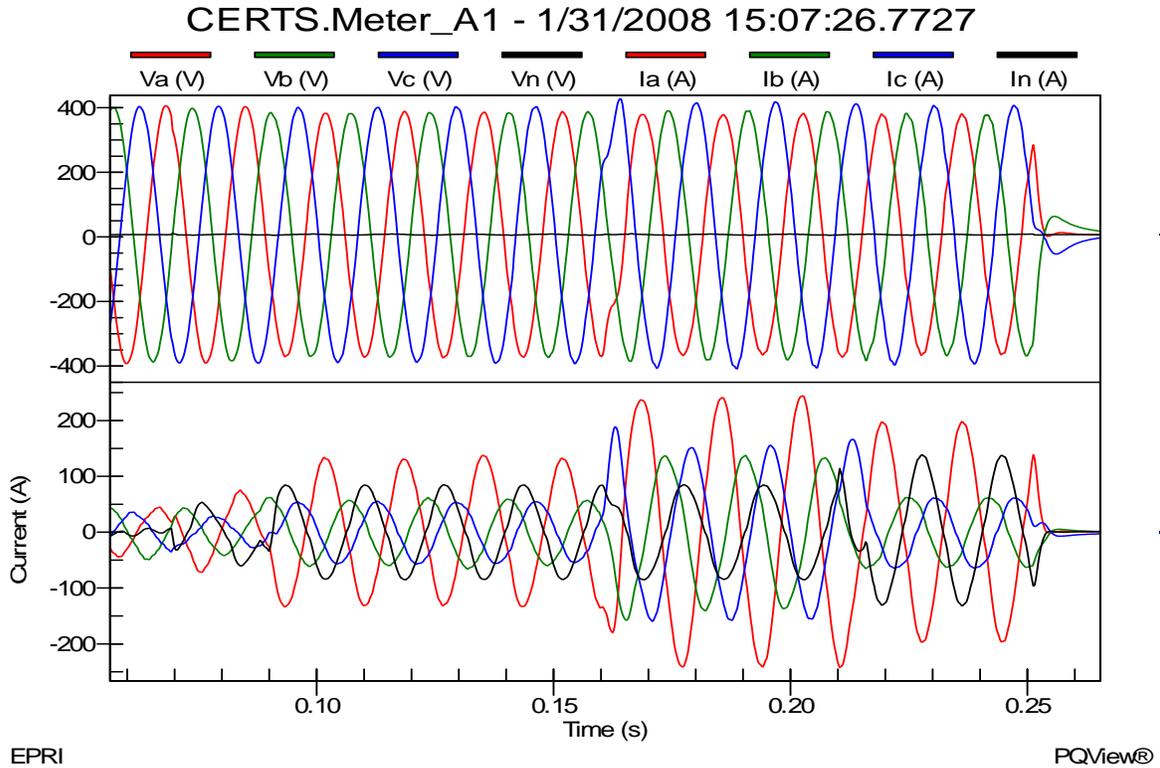
Figure 15g - Meter A1 voltage and current for a single phase-to-ground fault applied in Zone 3.

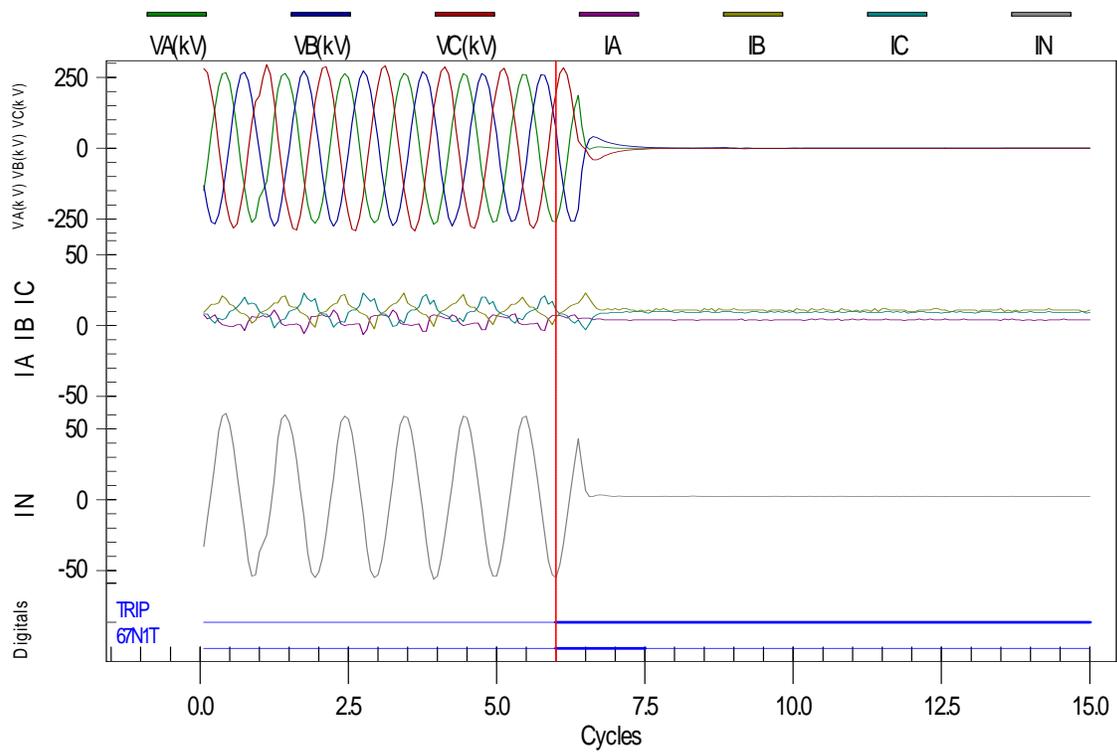
Figure 15i - Relay 3 (CB31) tripped due to a ground over-current (67N1T) when the single phase-to-ground fault was initiated in Zone 3

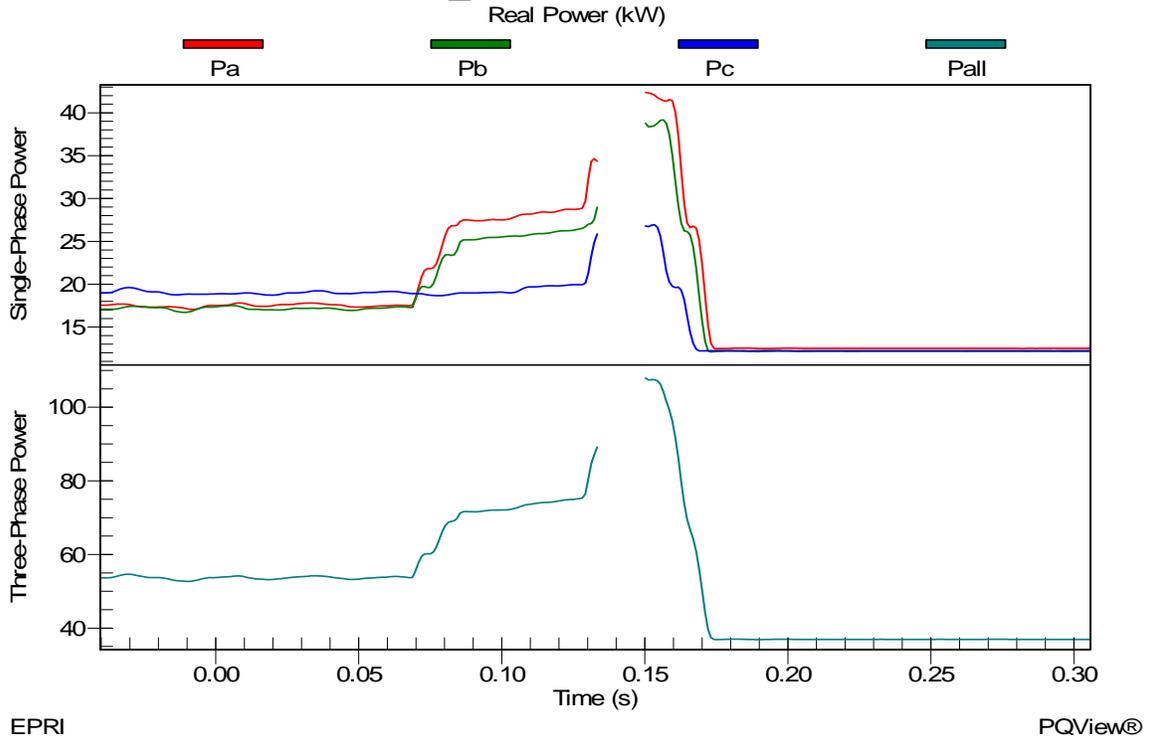
Figure 16a – Meter 1 power flow before/after the static switch opened, islanding the microgrid from the utility grid when a single phase-to-ground fault was applied in Zone 5.

After Gen-set B1 was running for a few minutes and supplying power to Load Bank 3, the test was started with a "Start" command from the EMS. As soon as the static switch closed and steady-state conditions established, the microgrid and Load Bank 6 were connected to the utility grid with total power flow at Meter 1 being approximately 54kW, shown in Figure 16a, and approximately 17.5kW at Meter 2 shown in Figure 16b before the fault was applied.

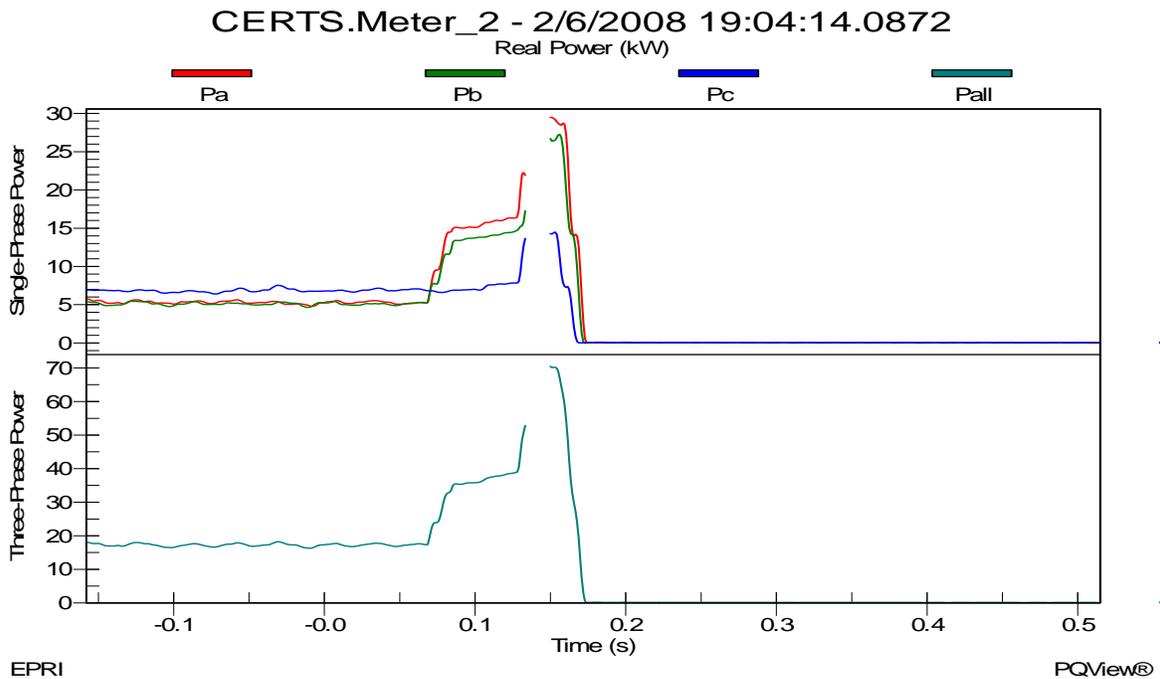
Figure 16b – Meter 2 power flow before/after the static switch opened, islanding the microgrid from the utility grid when a single phase-to-ground fault was applied in Zone 5.

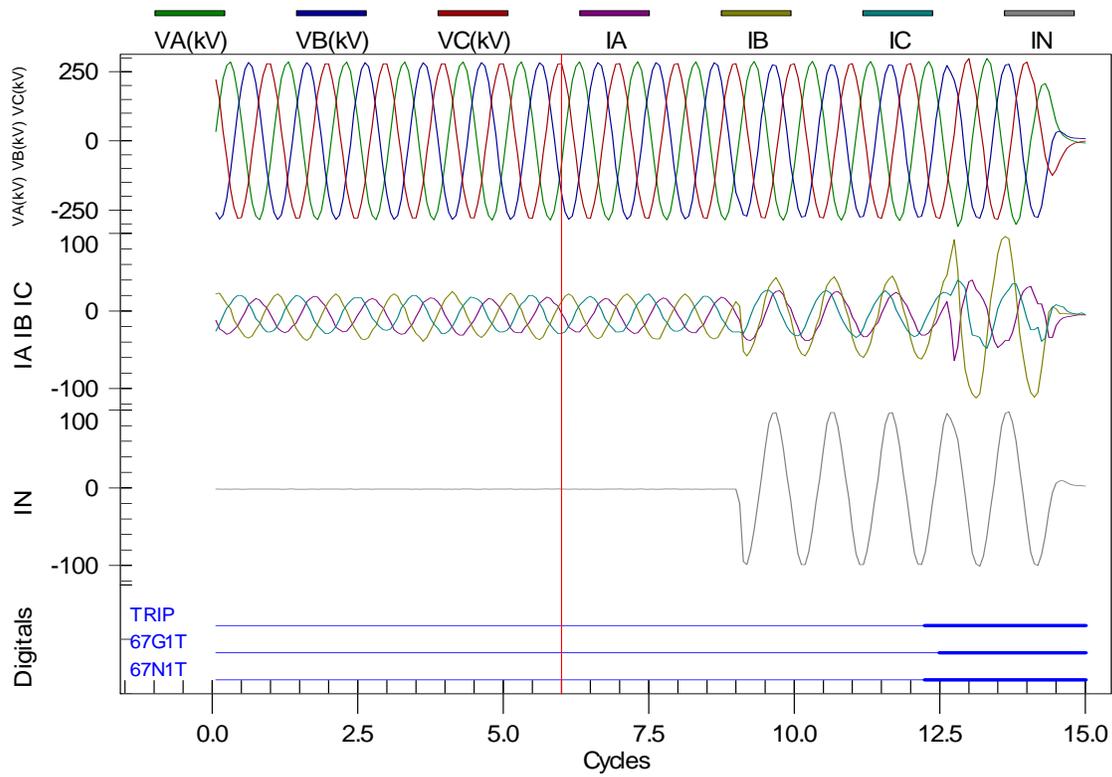
Figure 16c – Relay 5 (CB51) tripped due to ground over-current (67N1T) after the single phase-to-ground fault was initiated in Zone 5.

Using the DAS Load Control program, a single phase-to-ground overload fault on B-phase was set for 10 seconds and then initiated. The protection coordination for this event appears to be different than expected. After the fault is initiated Relay 5 first trips shutting down Gen-set B1 and opening CB51, Figure 16c. The Gen-set stops switching the inverter output, however its transformer contactor and CB51 remains closed for a brief period of time, Figure 16d. After the Gen-set stops switching the fault current at the static switch becomes large enough to cause Relay 2 to trip on negative sequence (67Q1T), Figure 16e. Relay 5 tripped first approximately 0.07 seconds (~4.2 cycles) separating Zone 5 from the rest of the microgrid. The static switch opened 0.03 seconds (~1.75 cycles) after Relay 5 tripped, islanding the microgrid from the utility.

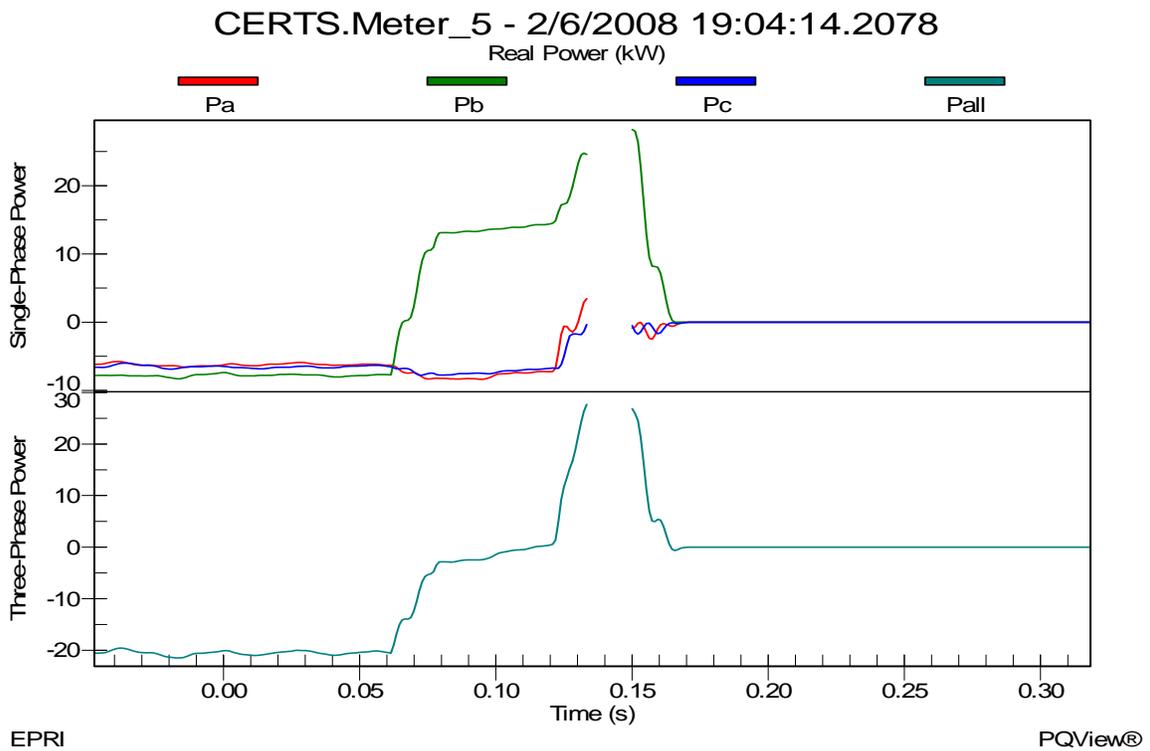
Figure 16d – Meter 5 power flow for a single phase-to-ground fault applied in Zone 5.

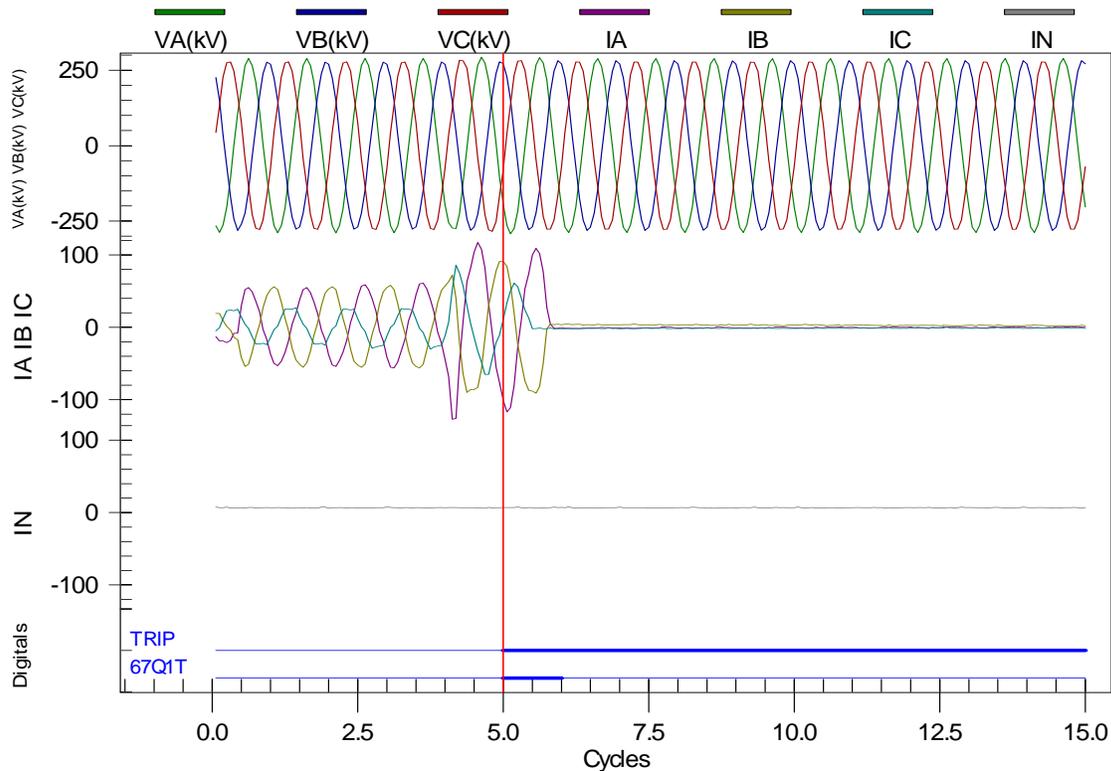
Figure 16e - Relay 2 (static switch) tripped due to negative sequence (67Q1T) after the single phase-to-ground fault was applied in Zone 5.

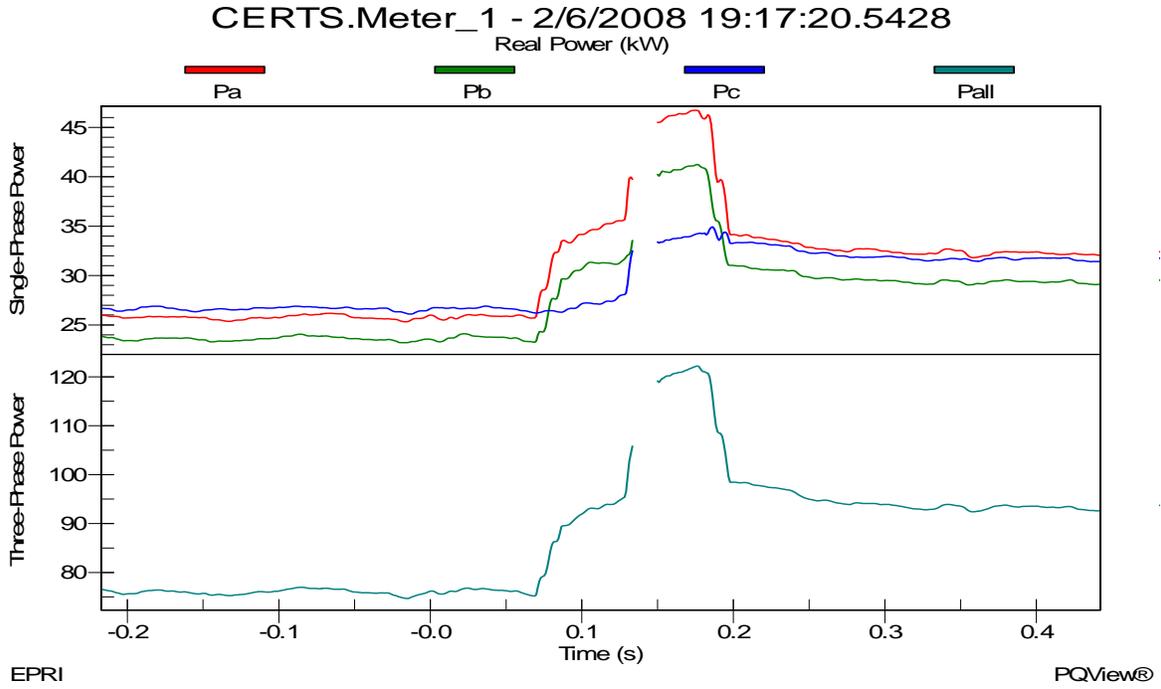
Figure 17a – Meter 1 power flow for a single phase-to-ground fault applied in Zone 5.

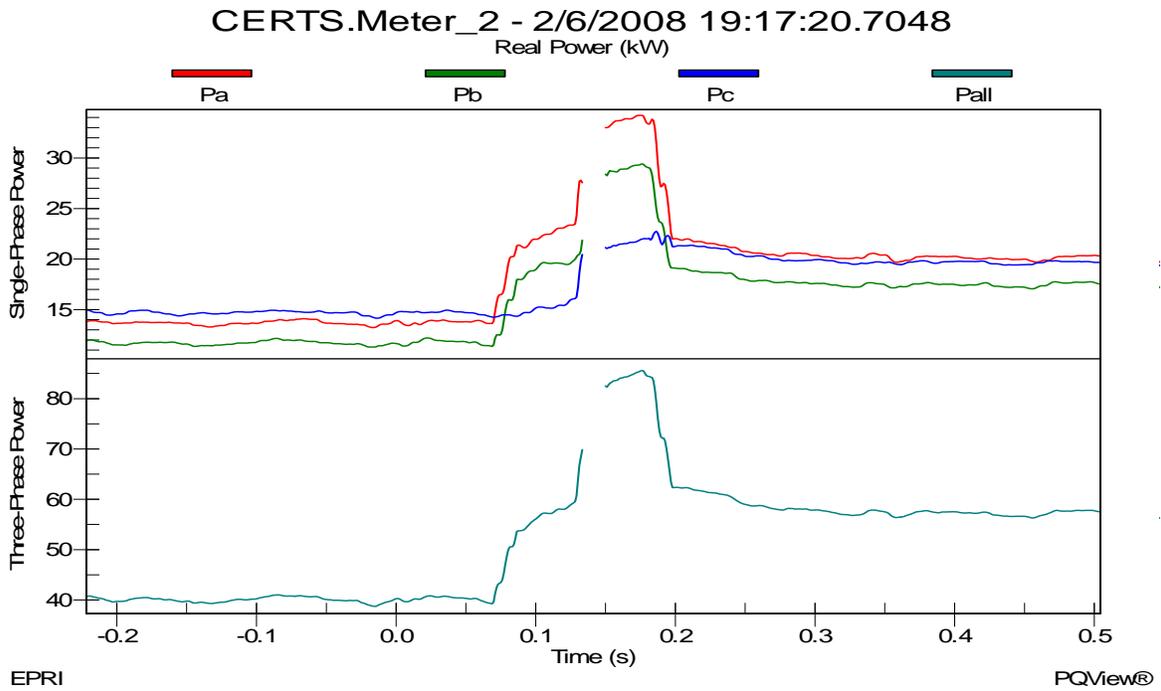
Figure 17b Meter 2 power flow for a single phase-to-ground fault applied in Zone 5.

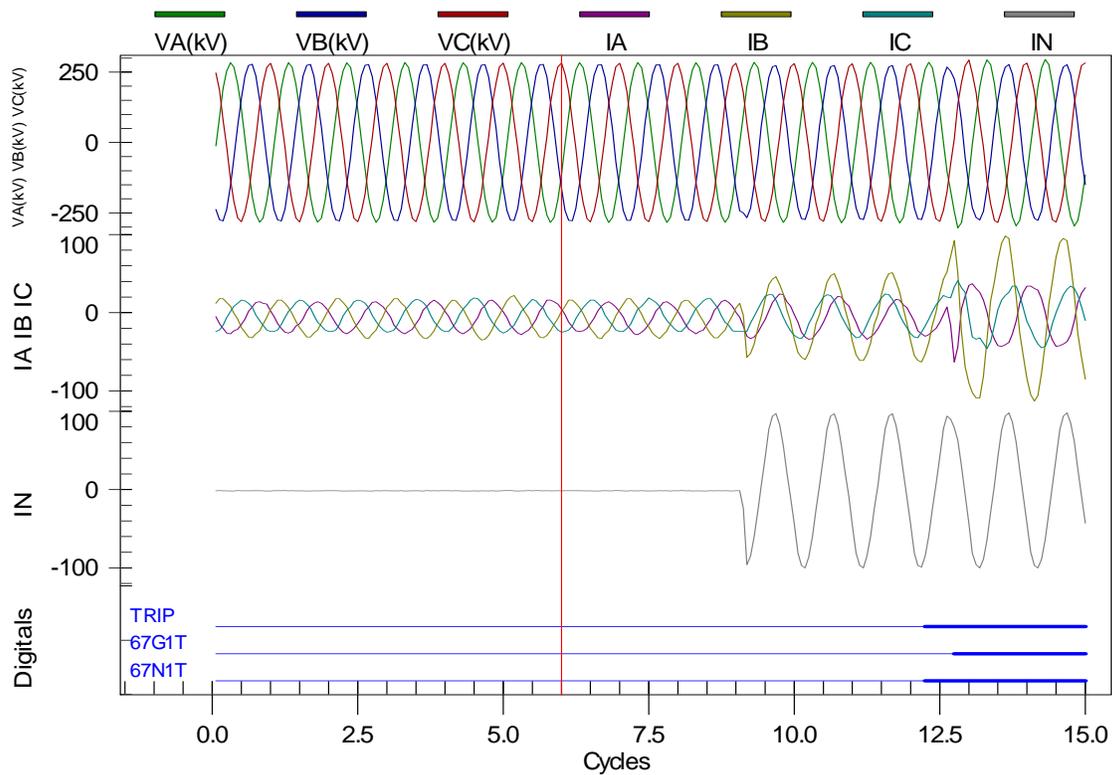
Figure17e - Relay 5 (CB51) tripped due to a ground over-current (67N1) after the single phase-to-ground fault was initiated in Zone 5.

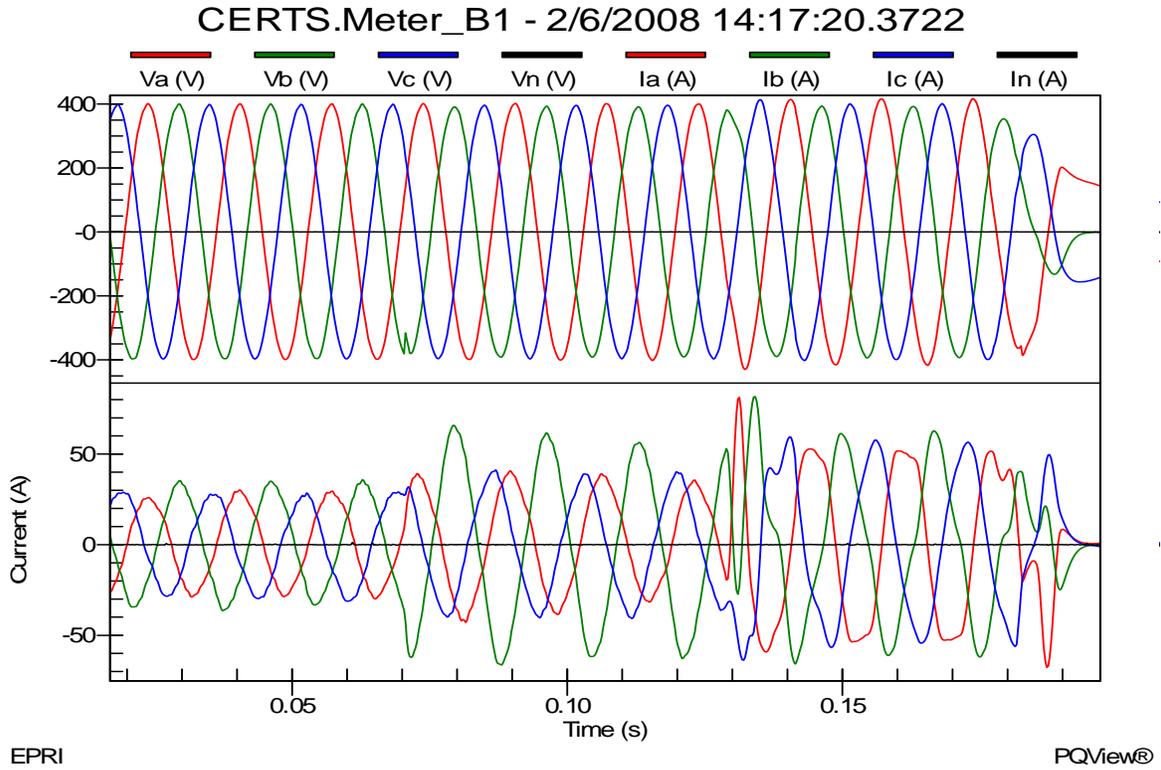
Figure17f – Meter B1 voltage and current for a single phase-to-ground fault applied in Zone 5.

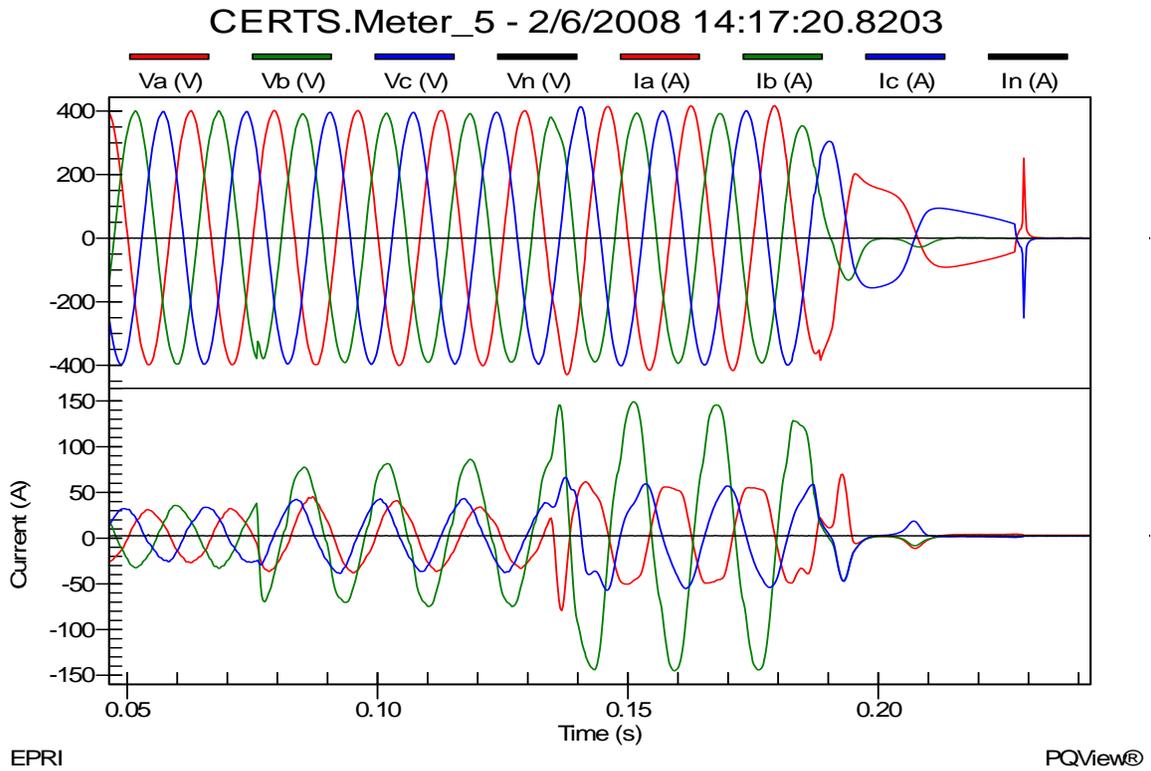
Figure17g- Meter 5 (CB51) voltage and current for a single phase-to-ground fault applied in Zone 5

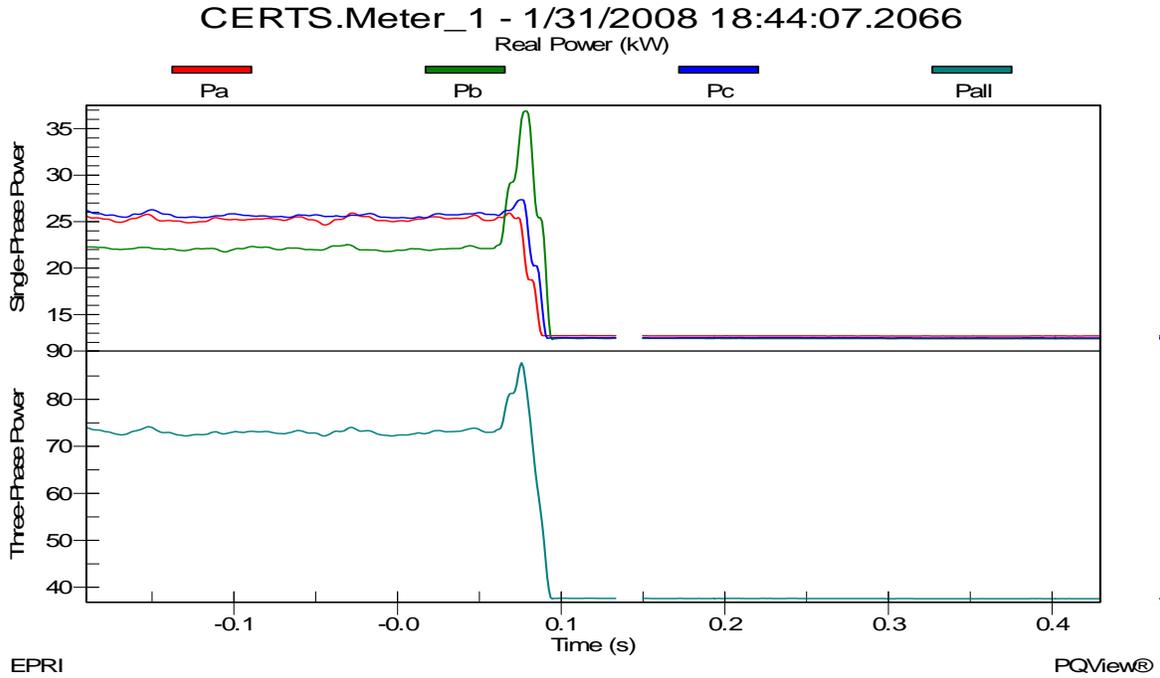
Figure 18a Meter 1 power flow before/after the static switch opened, islanding the microgrid from the utility grid when a single phase-to-ground fault was applied in Zone 4.

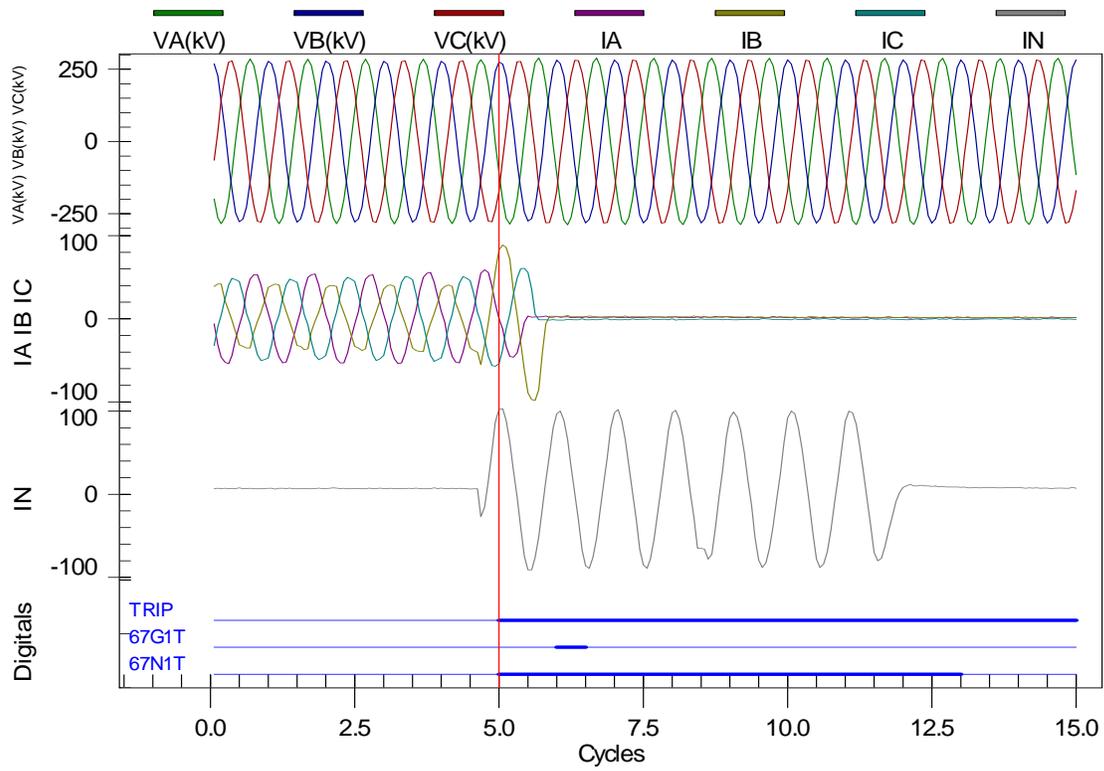
Figure 18e - Relay 2 (static switch) tripped due to a ground over-current (67N1T) when the single phase-to-ground fault is applied in Zone 4.

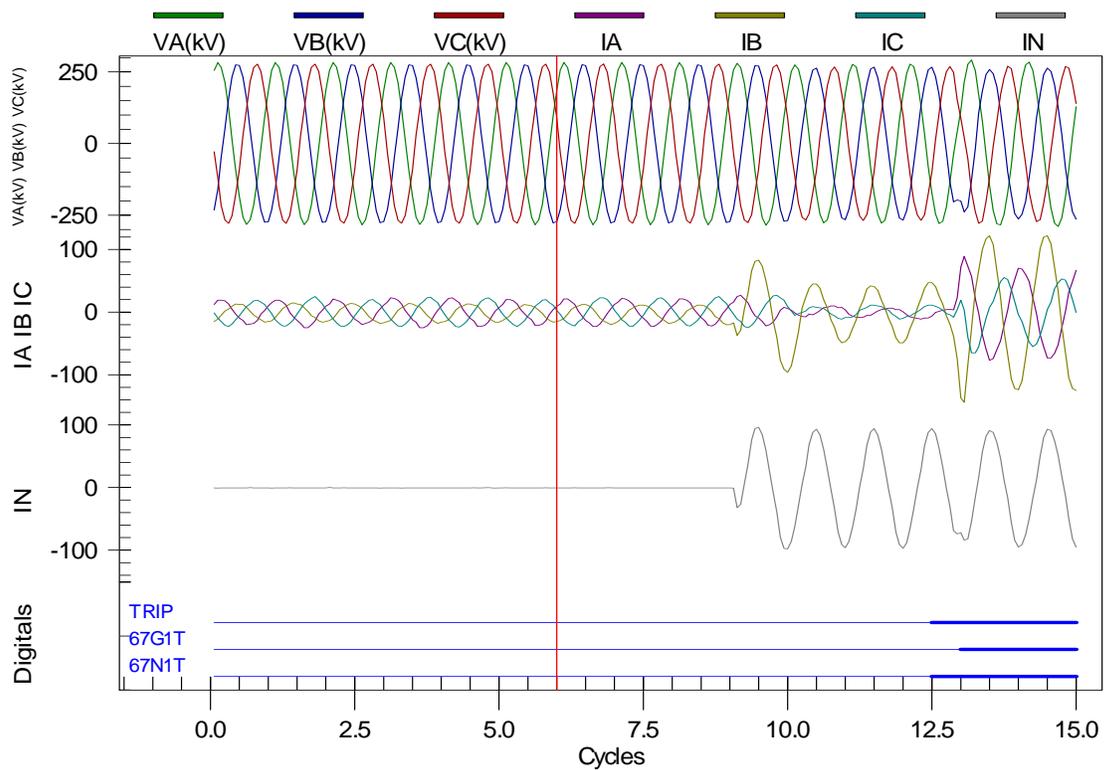
Figure 18f – Relay 4 (CB41) tripped due to a ground over-current (67N1T) when the single phase-to-ground fault was initiated in Zone 4

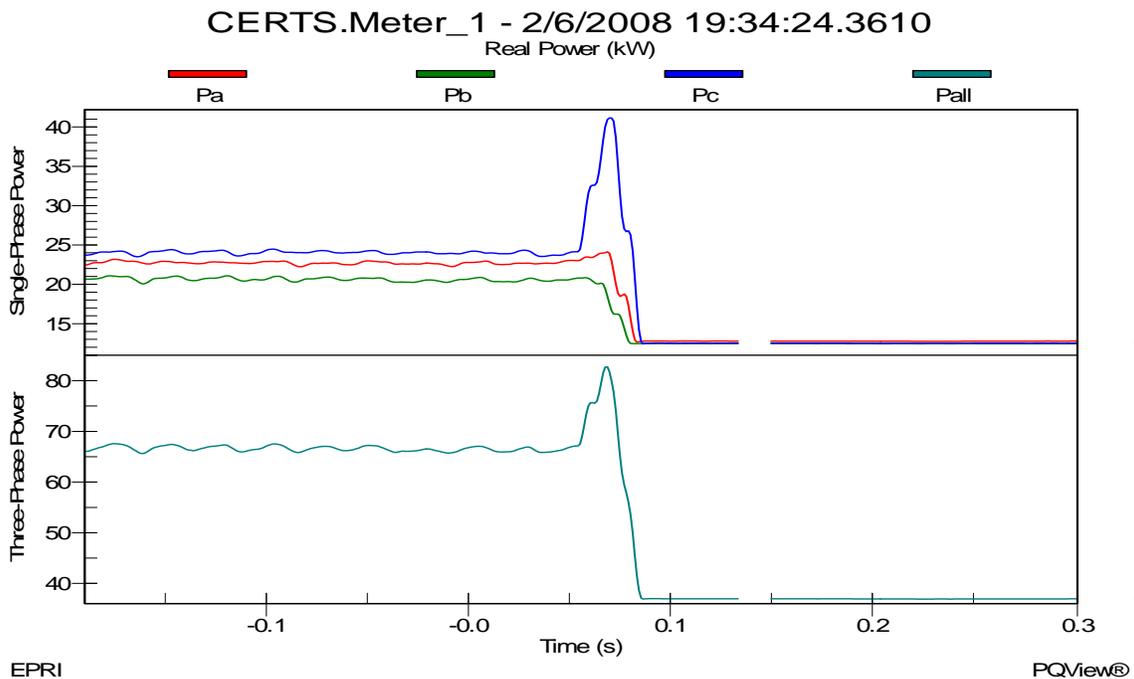
Figure 19a Meter 1 power flow before/after the static switch opened, islanding the microgrid from the utility grid when a single phase-to-ground fault was applied in Zone 2.

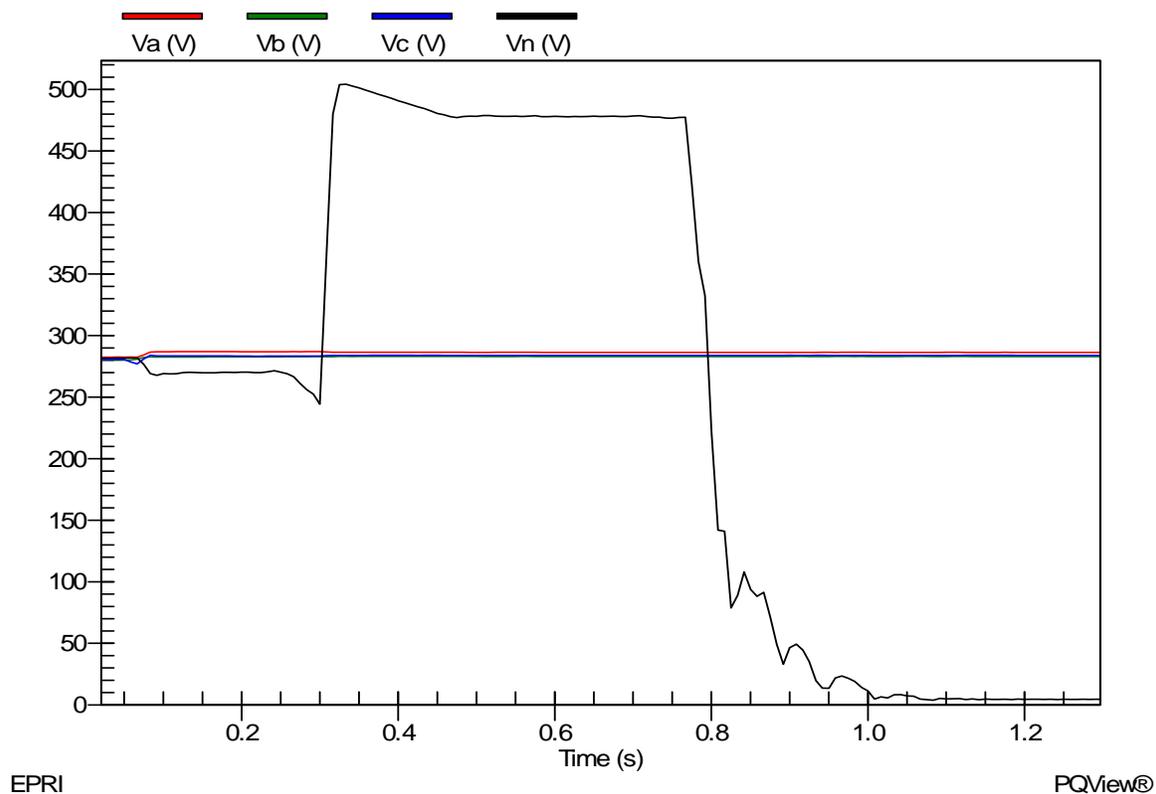
Figure 19g – Meter 2 RMS voltage before/after CB31 opened.

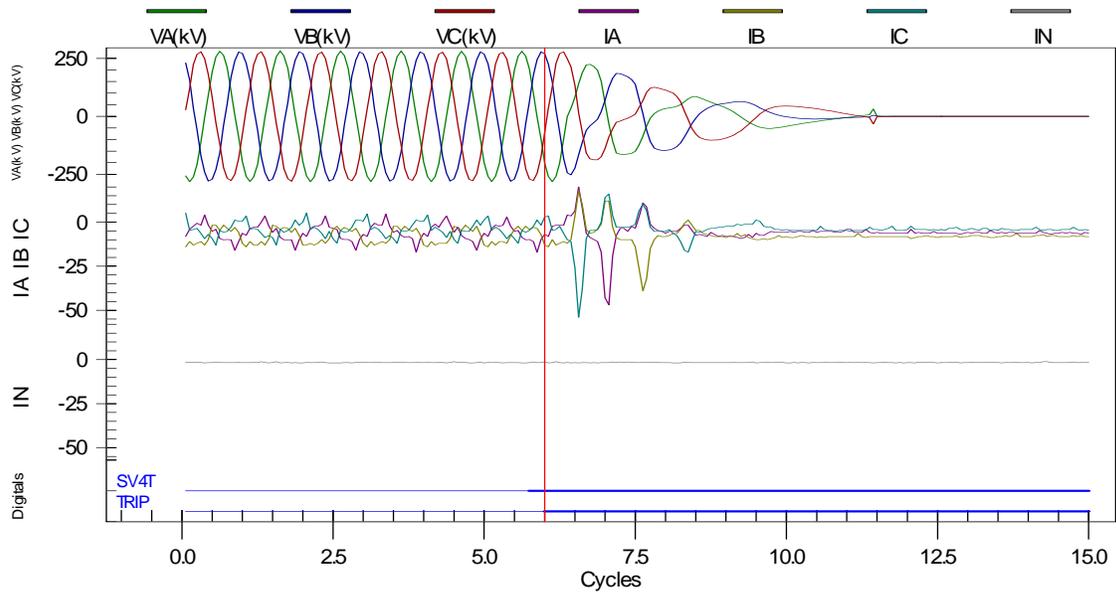
Figure 19h - Relay 5 (CB51) tripped due to an undervoltage at T51 when the single phase-to-ground fault was initiated in Zone 2.

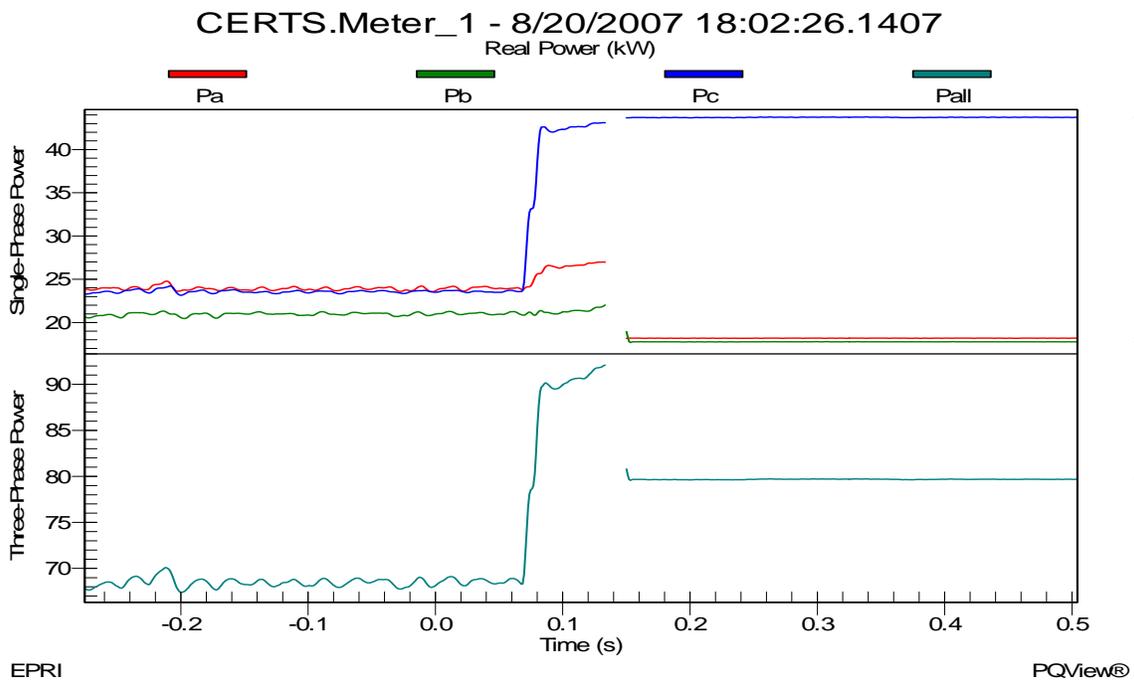
Figure 20a - Meter 1 power flow before/after the static switch opened, islanding the microgrid from the utility grid when a single phase-to-ground fault was applied in Zone 6.

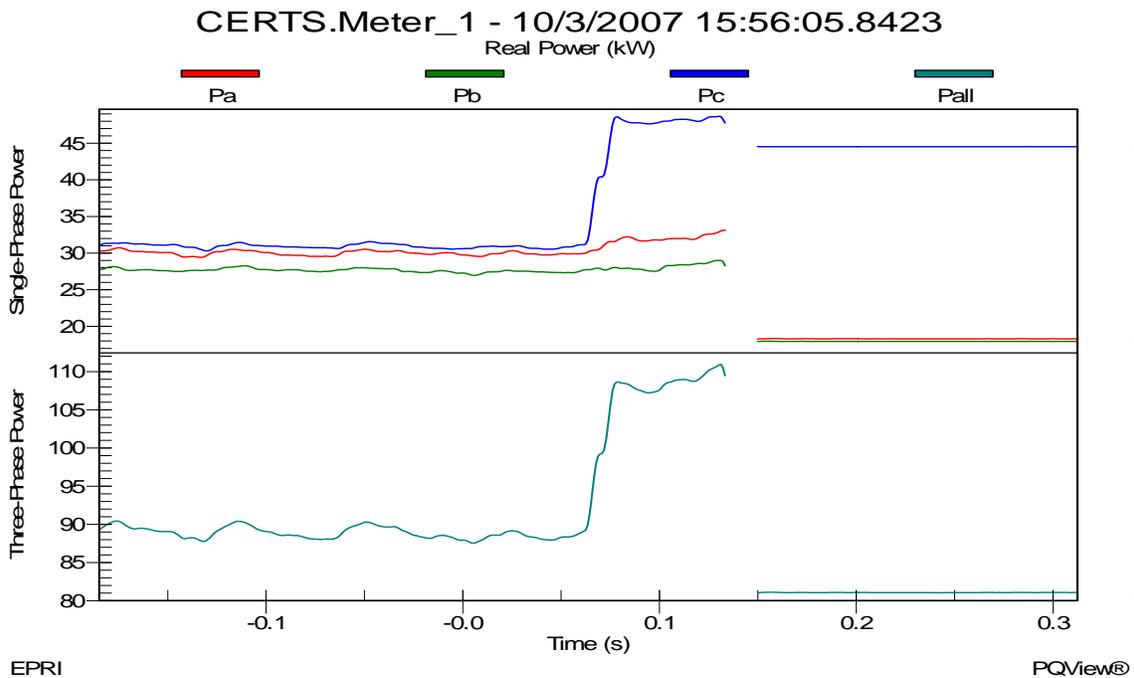
Figure 21a Meter 1 power flow before/after the static switch opened, islanding the microgrid from the utility grid when a single phase-to-ground fault was applied in Zone 6.

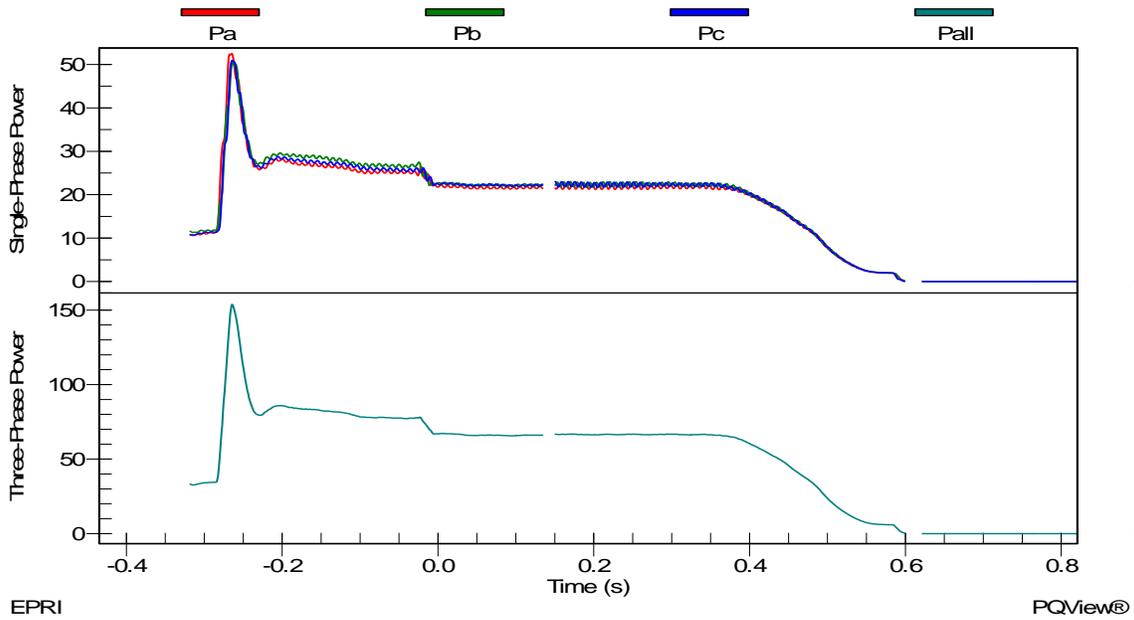
Figure 21f – Gen-set A1 shutting down due to a “No Field” fault.

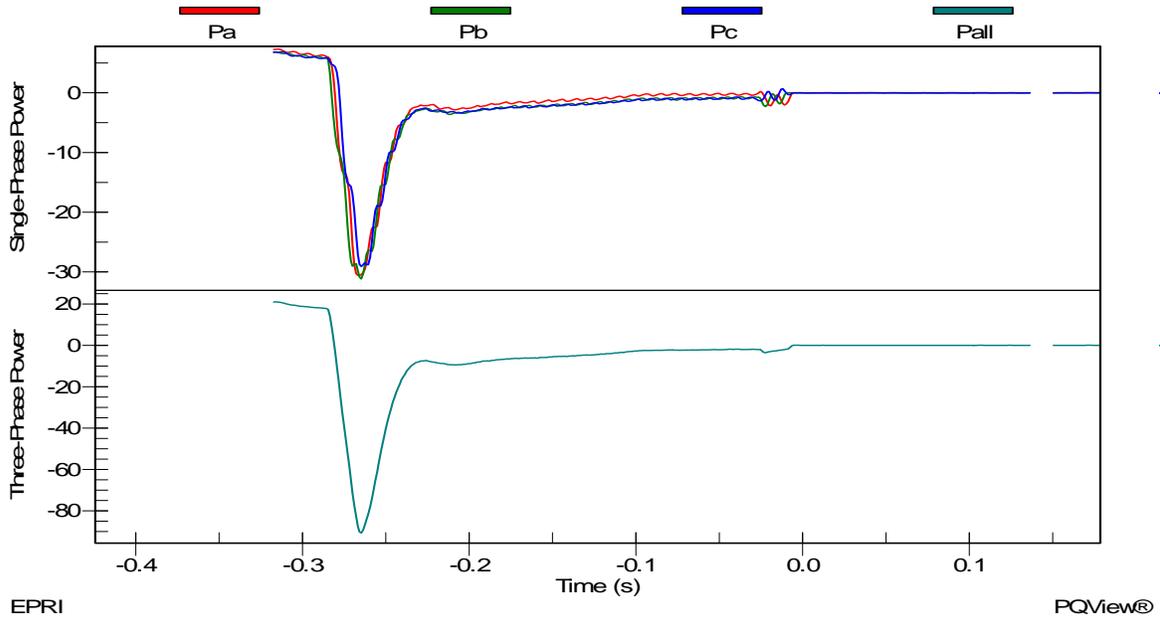
Figure 21g – Gen-set B1 shutting down due to a “Boost” fault

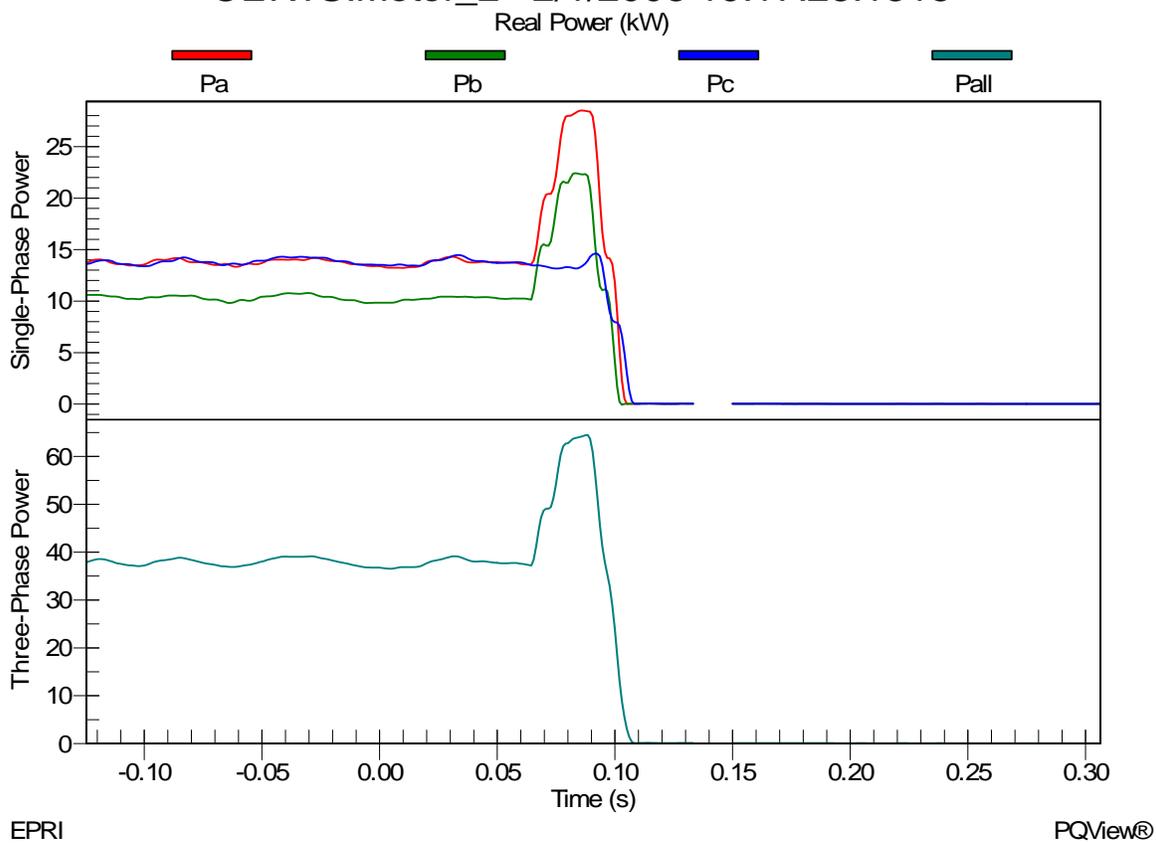
Figure 22b – Meter 2 power flow before/after the static switch opened, islanding the microgrid from the utility grid when a phase-to-phase fault was applied in Zone 3.

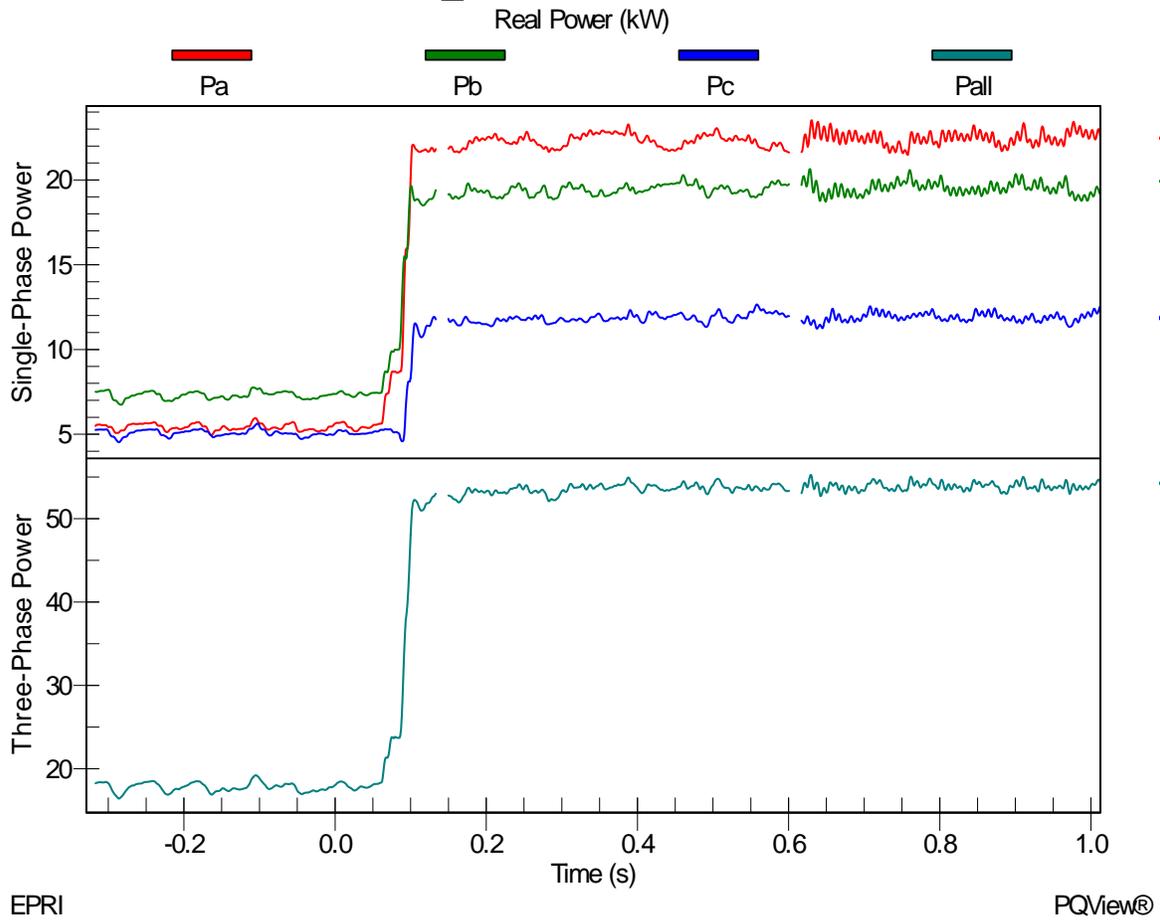
Figure 225c - Power produced by Gen-set A1 before/after the static switch opened when an A-to-B phase fault was applied in Zone 3.
